# FLOOD PLAIN MANAGEMENT STUDY **COPPER RIVER COMMUNITIES**

# **FLOOD PLAIN MANAGEMENT STUDY**

## **COPPER RIVER COMMUNITIES**

Includes Gakona, Gulkana, Copperville Subdivision,  
Tazlina, Silver Springs Subdivision, Copper Center,  
Tonsina, and Lower Tonsina

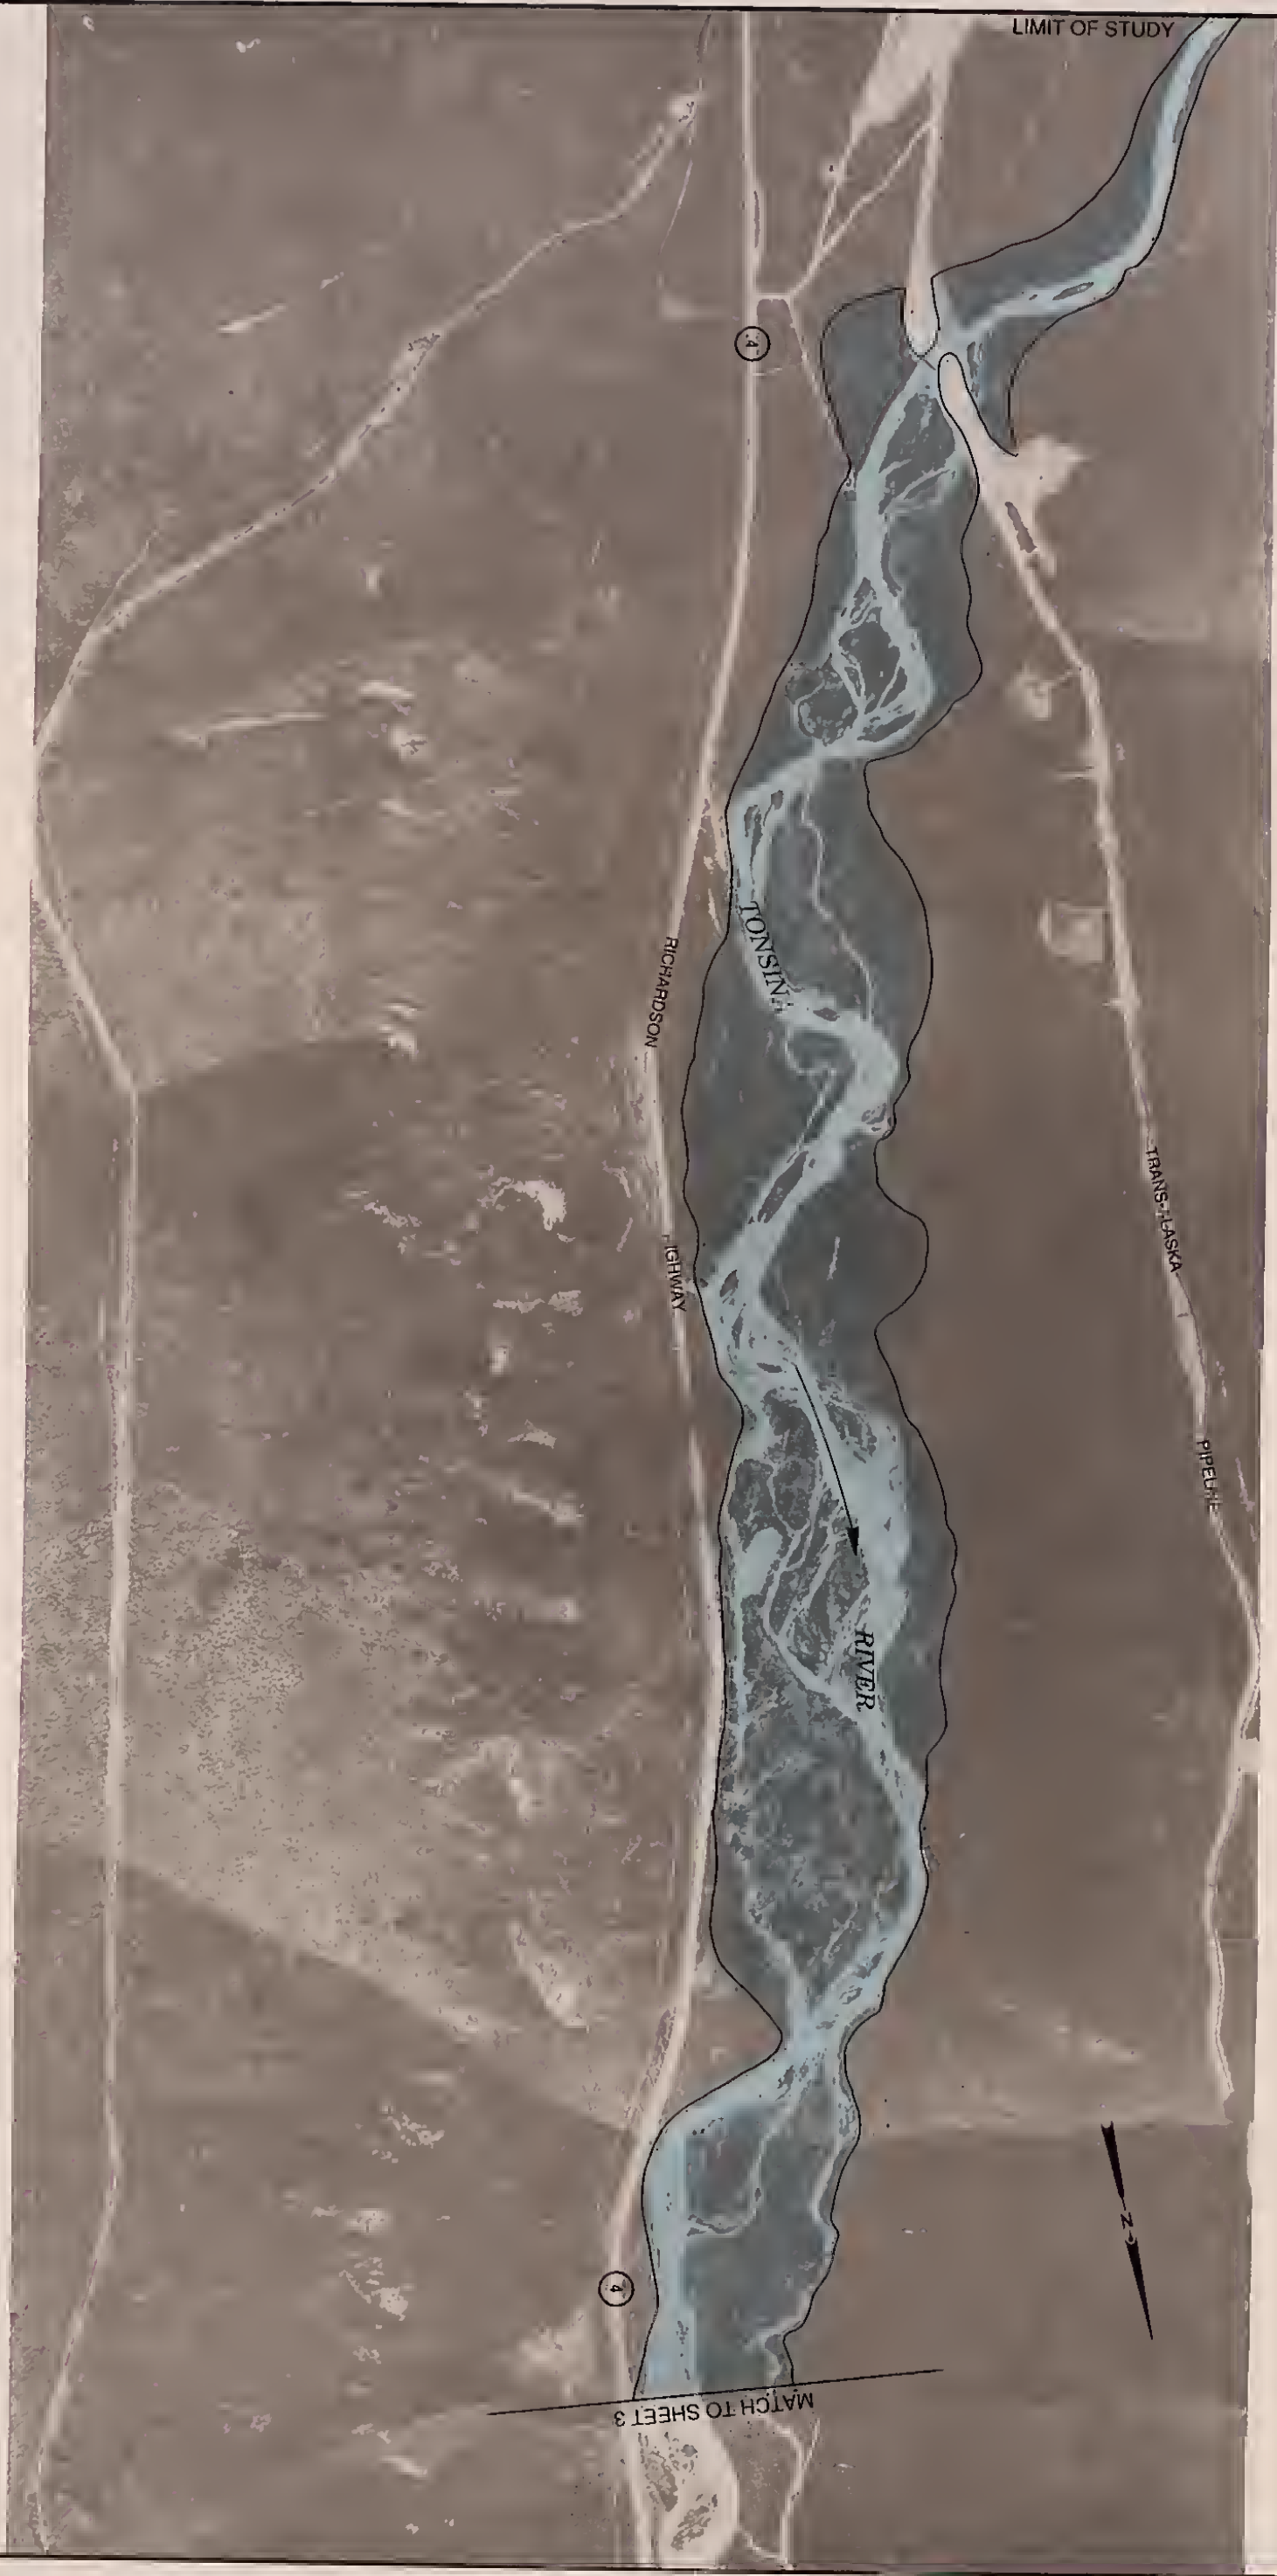
LOWER TONSINA

FLOOD HAZARD AREA

The boundary shown on the flood plain management maps was approximated using soils and vegetation mapping, geomorphic surfaces, and the historical record. It should be considered a minimum estimate. As the flood boundaries shown are estimates and the actual limits of overflow may vary somewhat from those shown on the maps because the scale of the maps does not permit precise plotting of the flooded area boundaries, it is recommended that a "freeboard allowance" of at least two feet above shown boundaries be provided for any new development or mitigation measure.

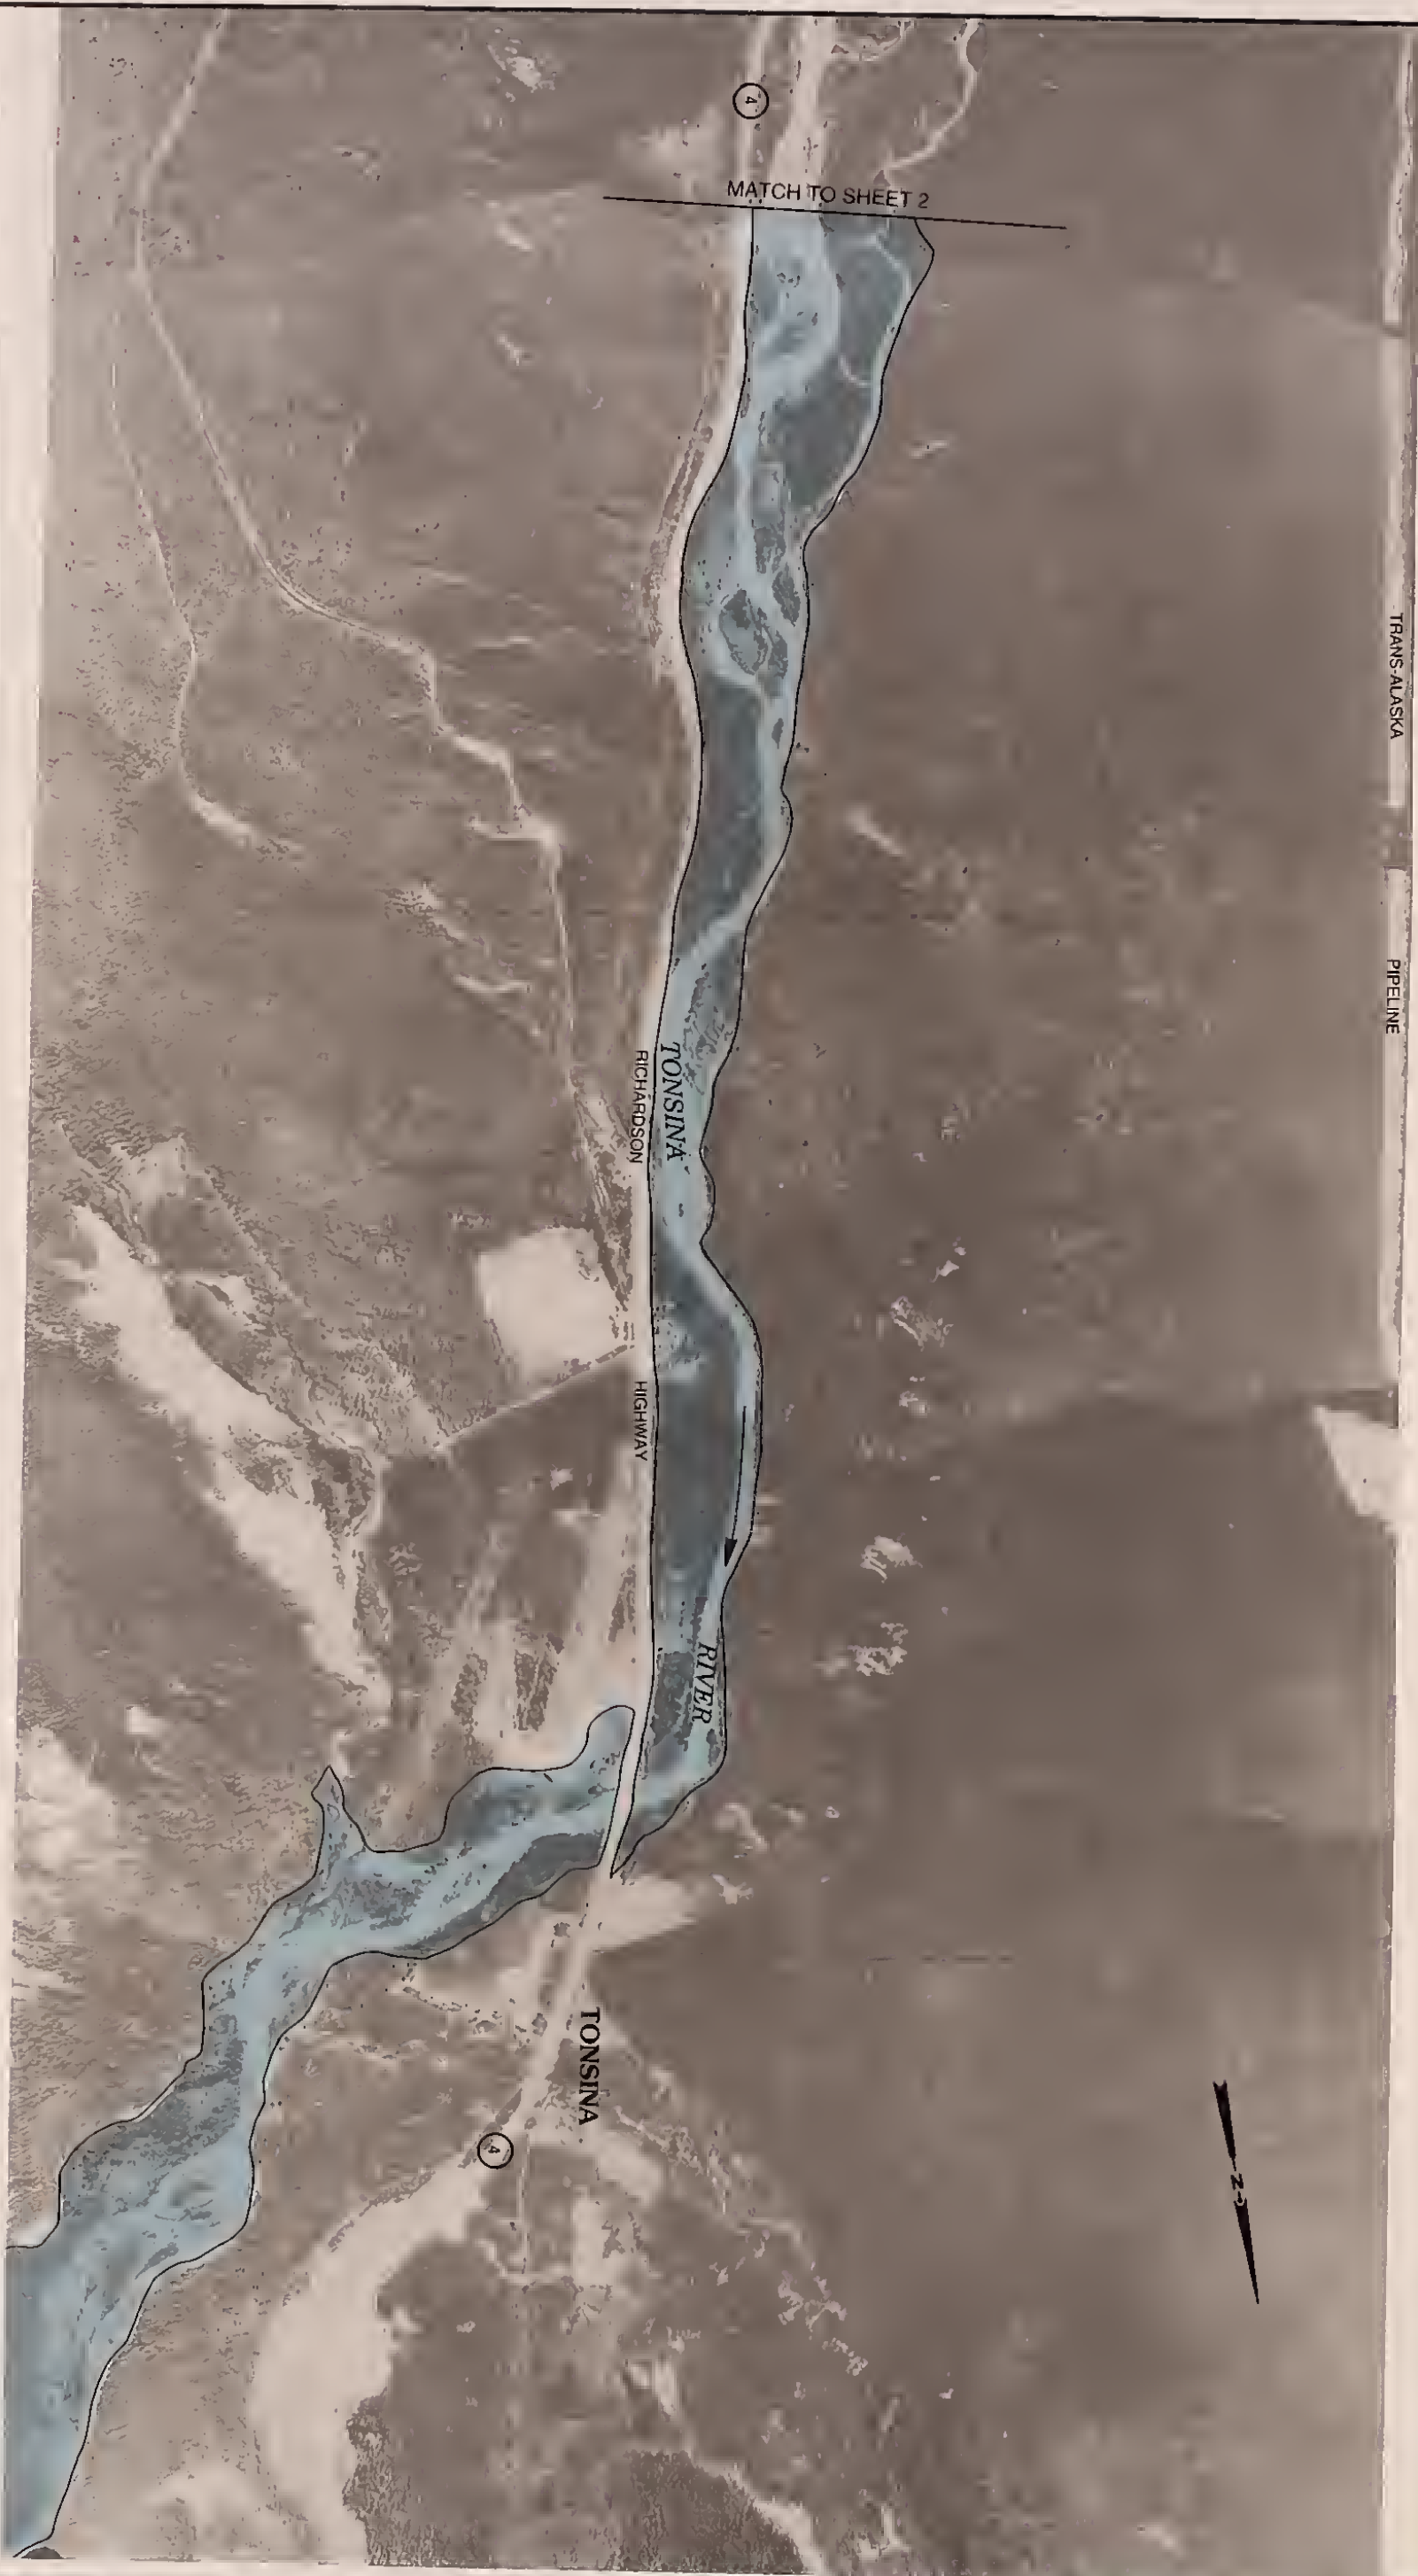
**TONSINA**

**FLOOD HAZARD AREA**

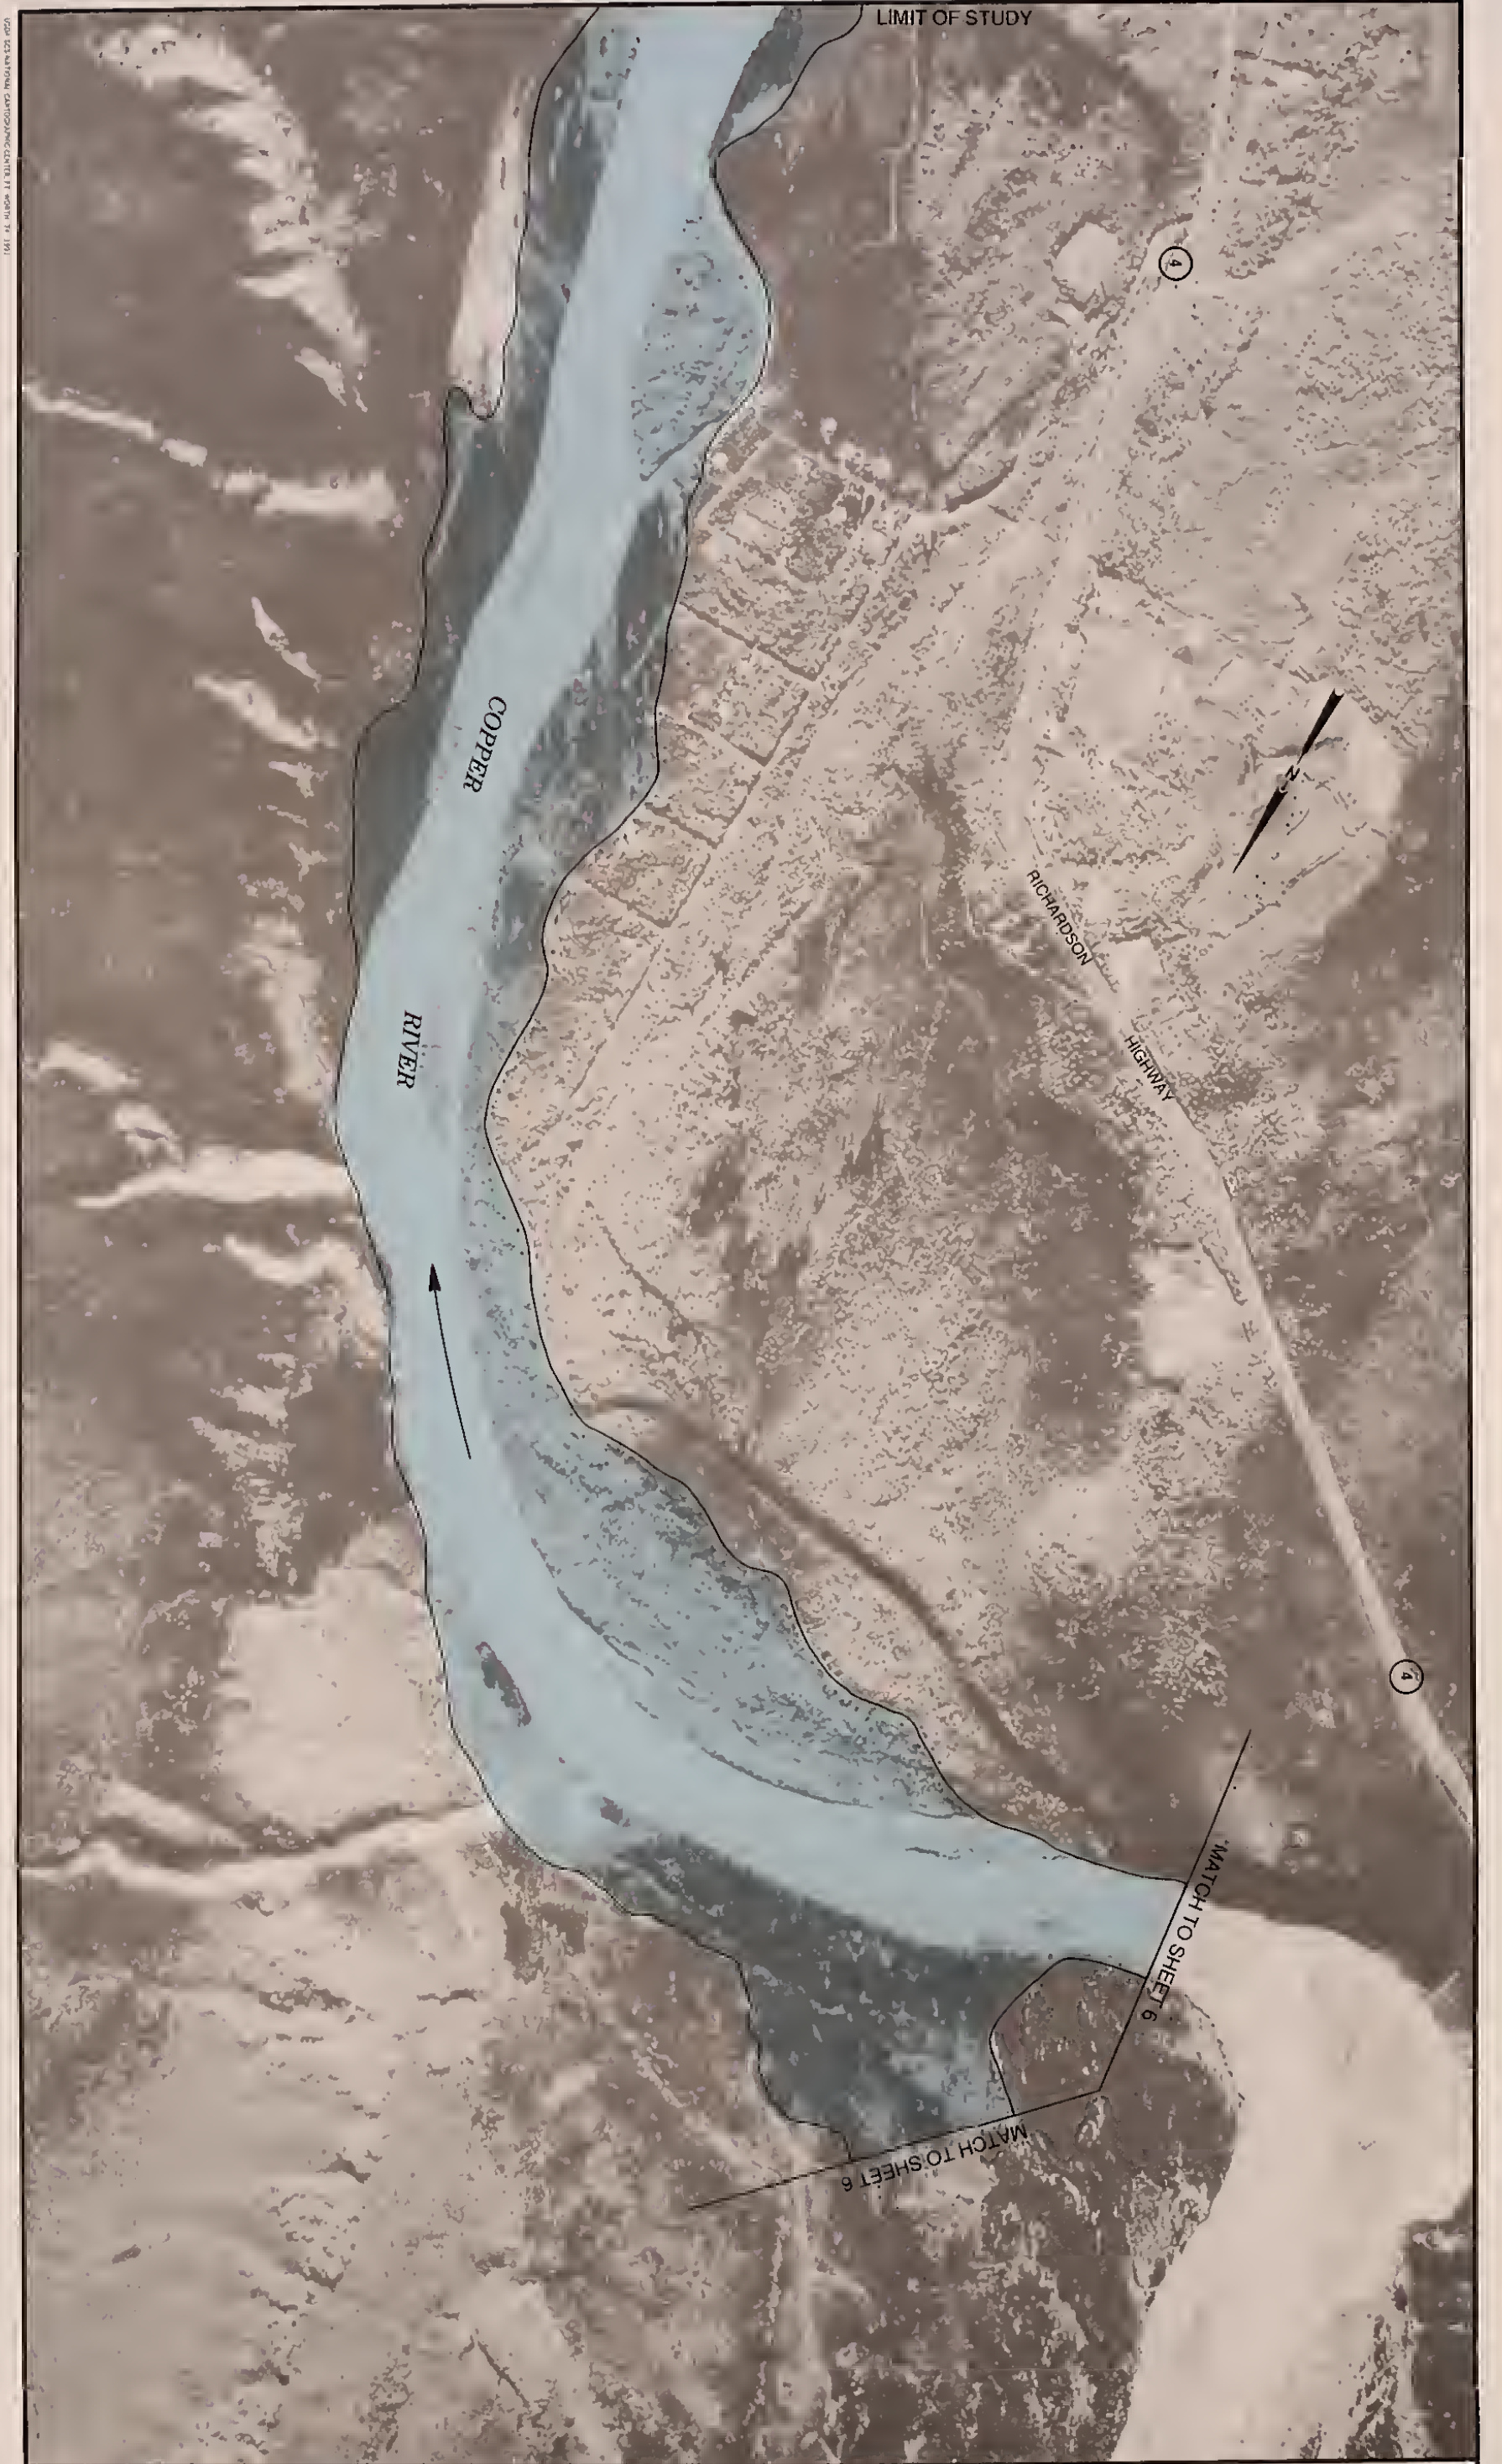
## COPPER CENTER

# FLOOD HAZARD AREA

Flooding on the Klutina River at Copper Center has occurred a number of times but reportedly never from normal periods of high water from snow and glacial melt or rainfall. Flooding is more likely to be the result of aufeis and subsequent overtopping of channel banks. Since the construction of the Army Corps of Engineers dike along the north side of the river in 1972 protecting Copper Center, there has been no flood of record. The Copper River itself has not caused flooding of the Copper Center area though there is some threat of erosion of the west bank of the Copper River during high flows. Site survey and soils survey information were used to delineate the flood boundary.

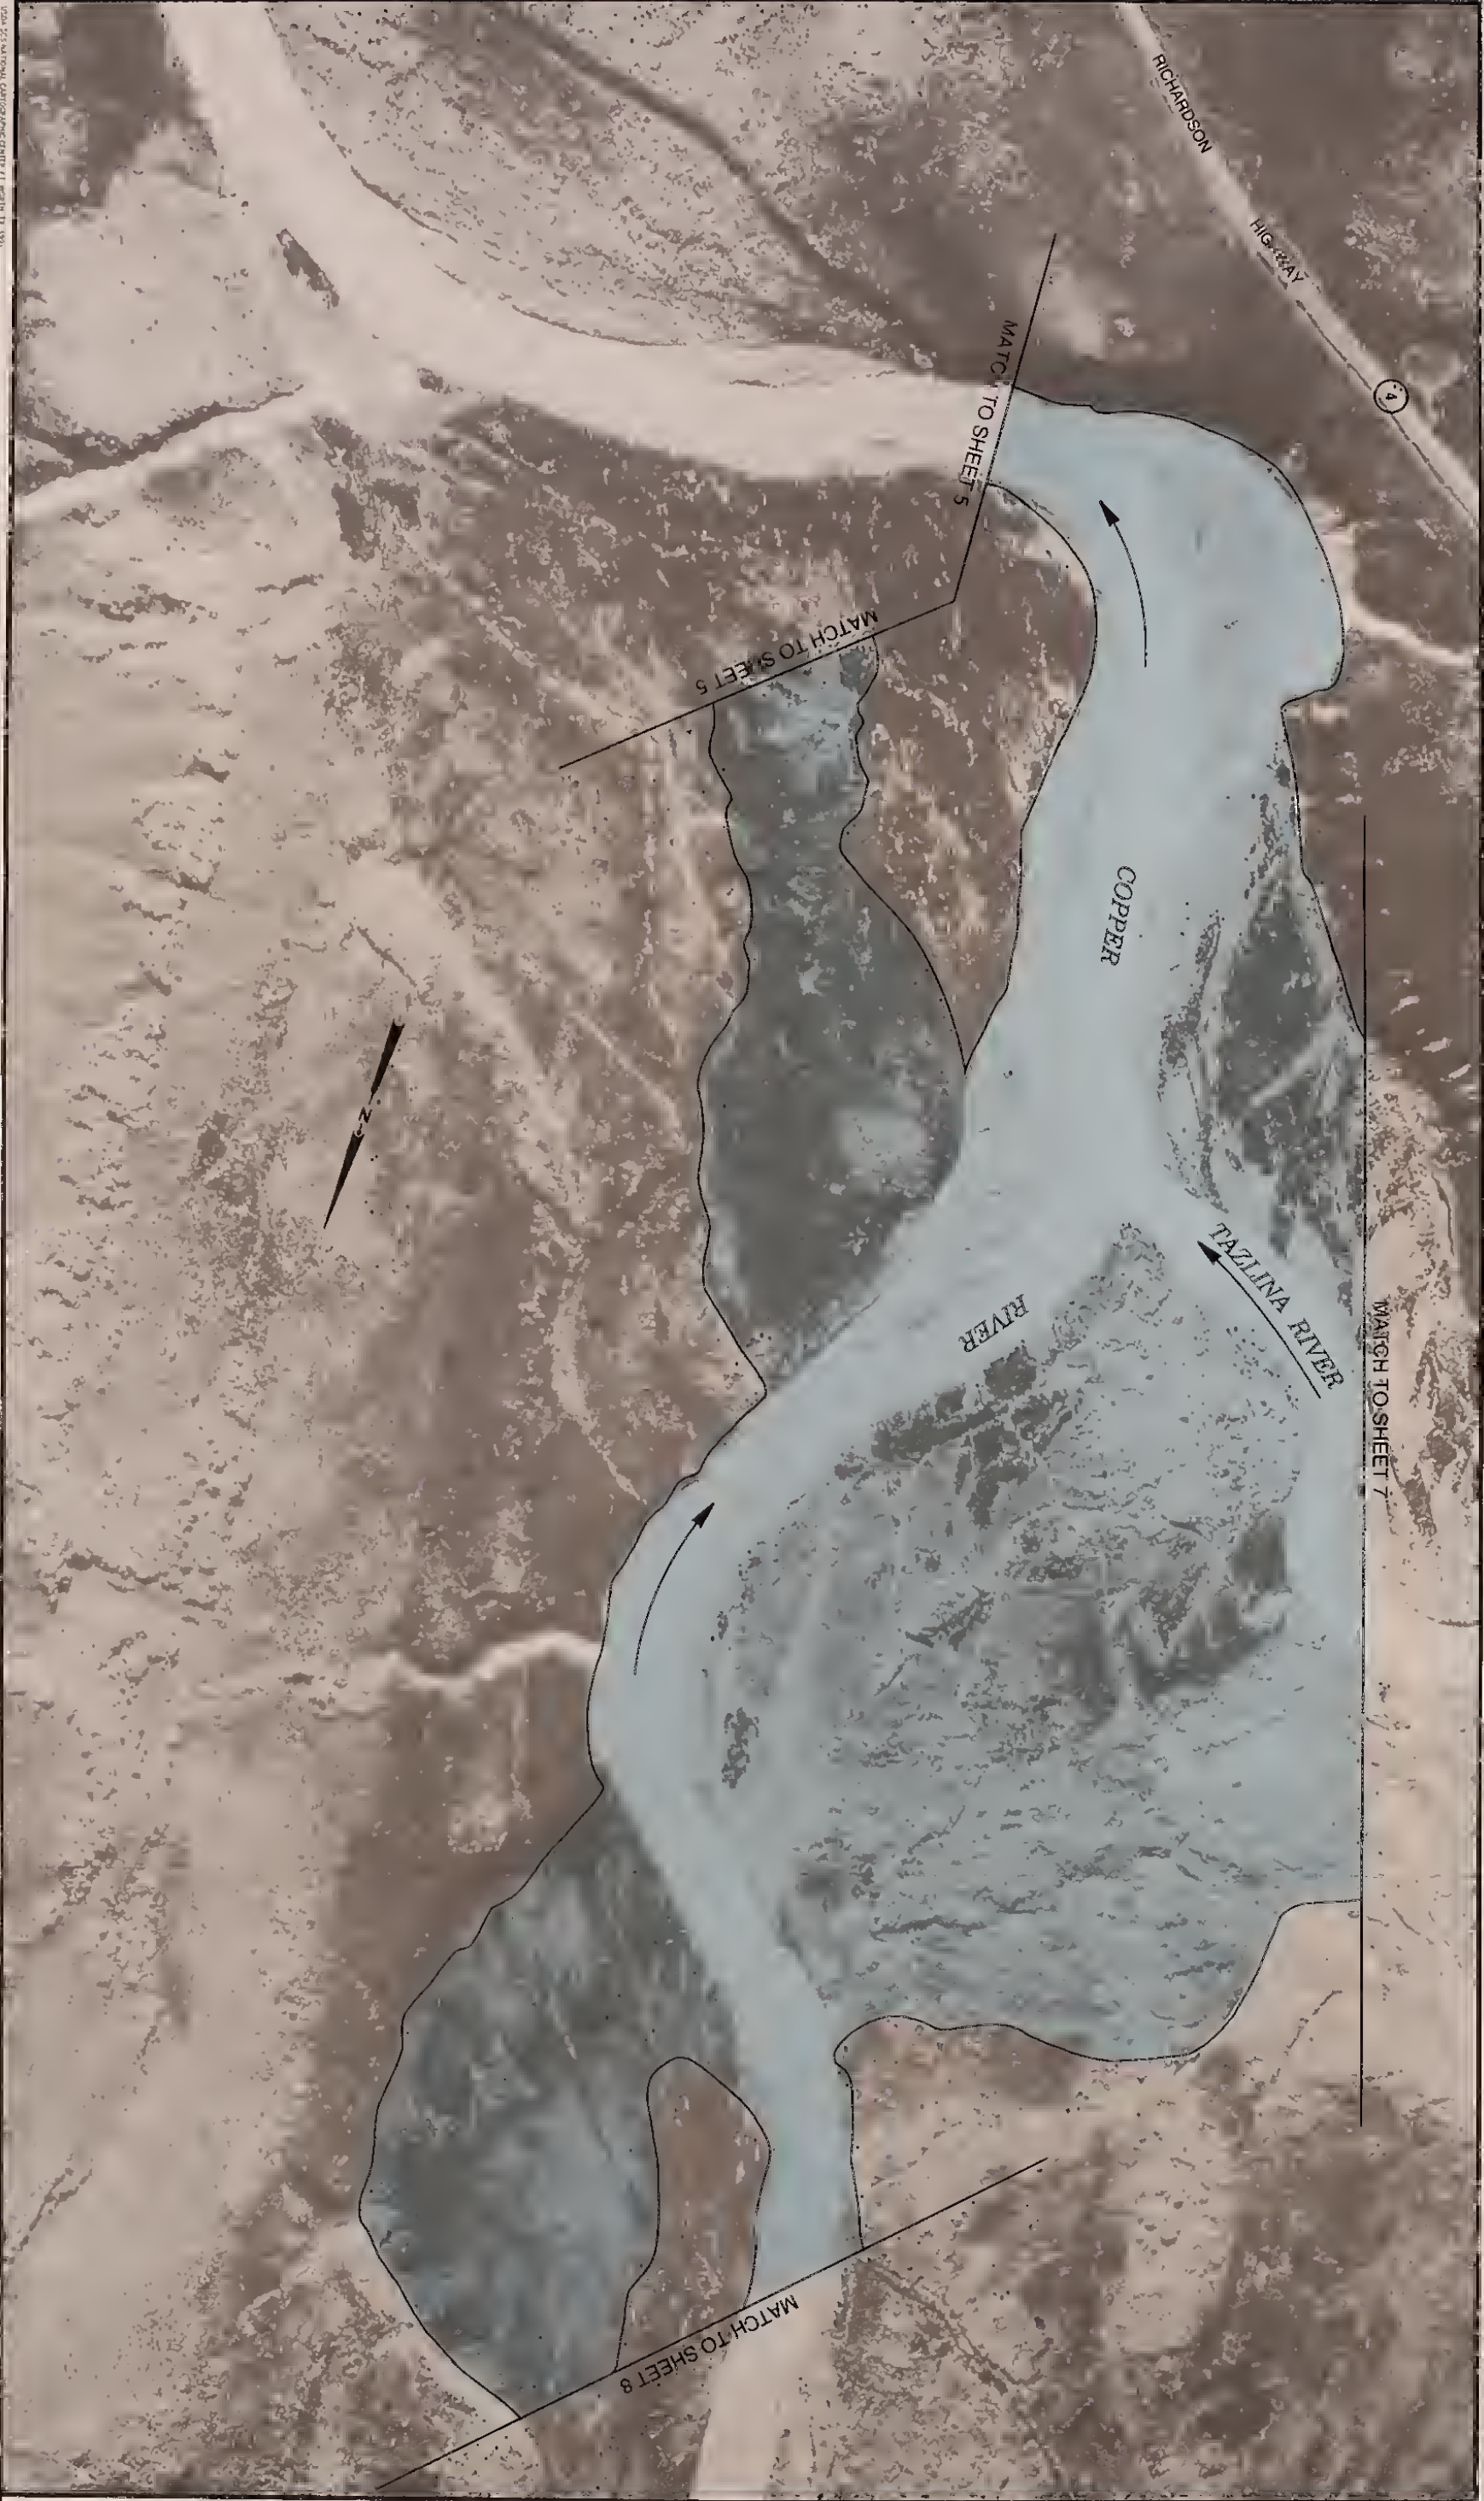
**SILVER SPRINGS**

**FLOOD HAZARD AREA**

Though there is no record of flooding in the subdivision, one subdivision house on the bank of the Copper River is in the immediate flood plain and predictably can expect damage in the future. Flood prone boundaries were predicted using site survey and soil survey information. Geomorphic terraces are obvious in this area along the Copper, and the first terrace above the river channel was used to facilitate boundary determinations.

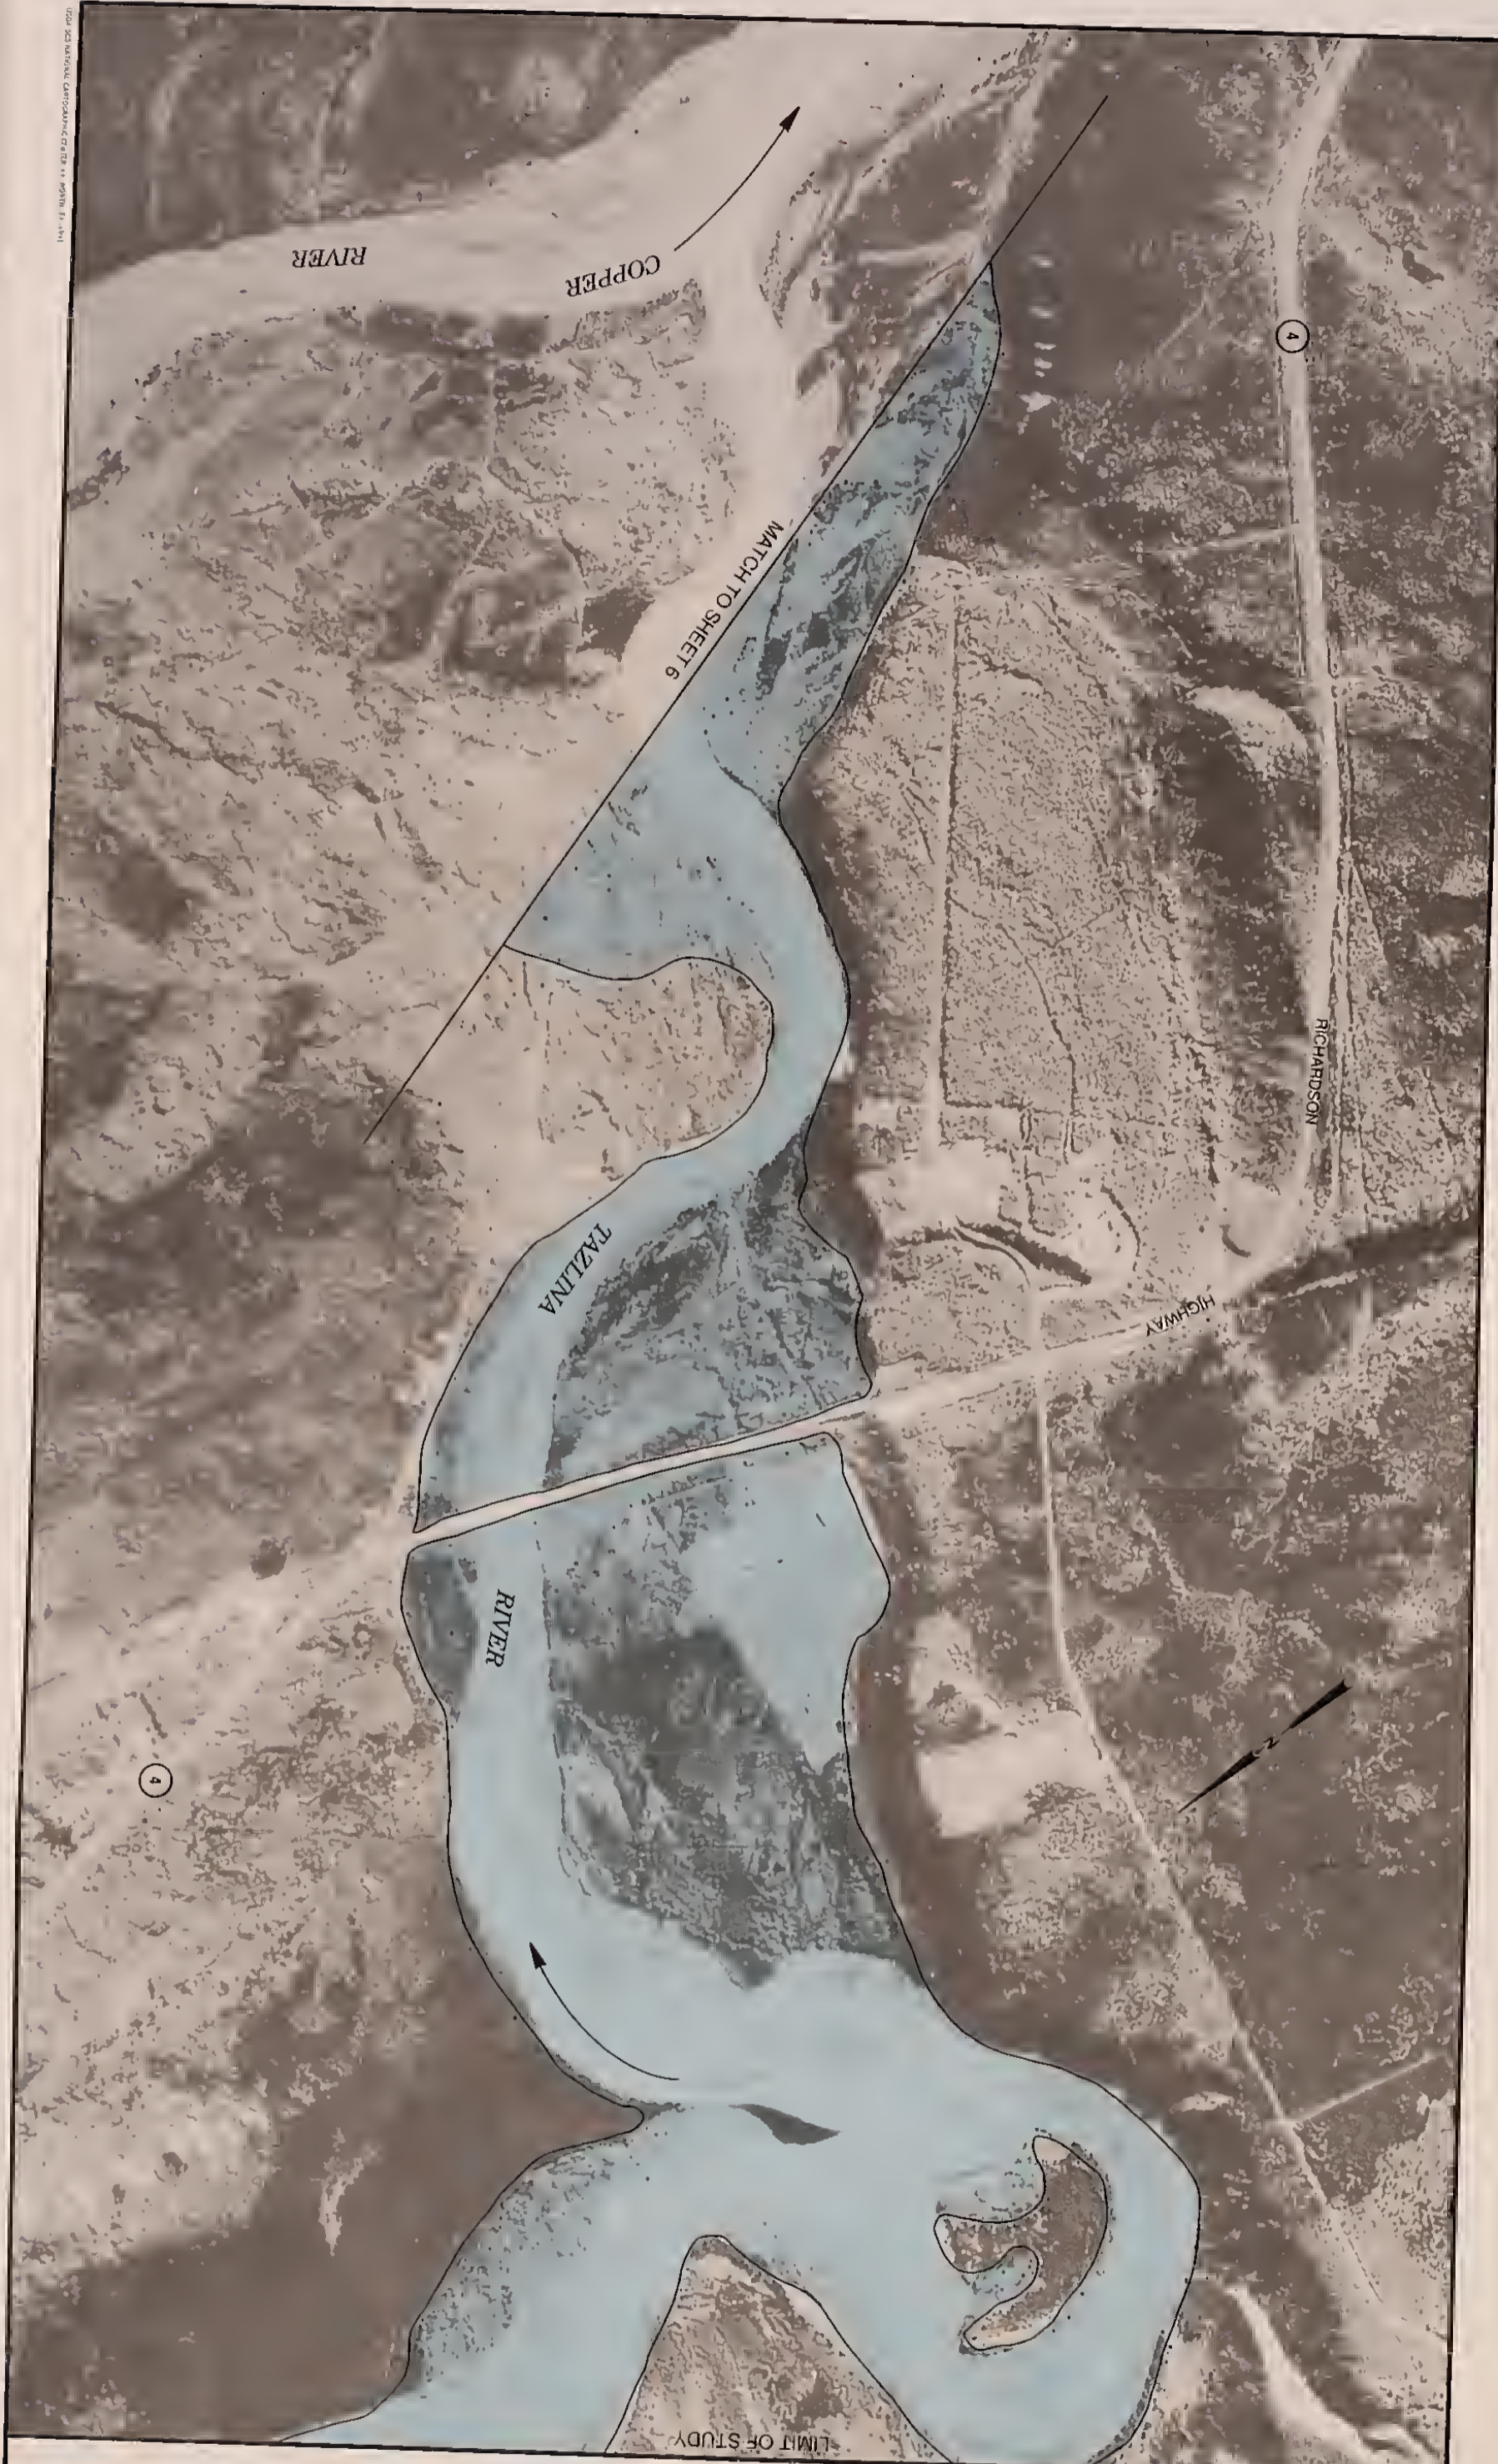
**TAZLINA AND COPPERVILLE**

**FLOOD HAZARD AREA**

Ice jams on the Copper River at a constriction downstream of this subdivision cause flooding of those residences in the lowest lying areas. There is no flow data on this part of the Copper River or topographical survey data to predict high flow occurrences, and there is no historic record of high flow flooding; however, soils mapping in the area demonstrates flood prone soils to a much greater extent than otherwise predictable. Soil survey and site survey information were used to predict flood prone boundary.

Glacial outburst flooding events cause most of the flooding damage and occur fairly predictably on a 2- 3-year cycle in the early fall. Since the cut-off of the meander loop upstream of the bridge, there is increased probability of erosion of the right bank downstream of the cutoff. Site survey and soils survey information were used to delineate the flood boundary.

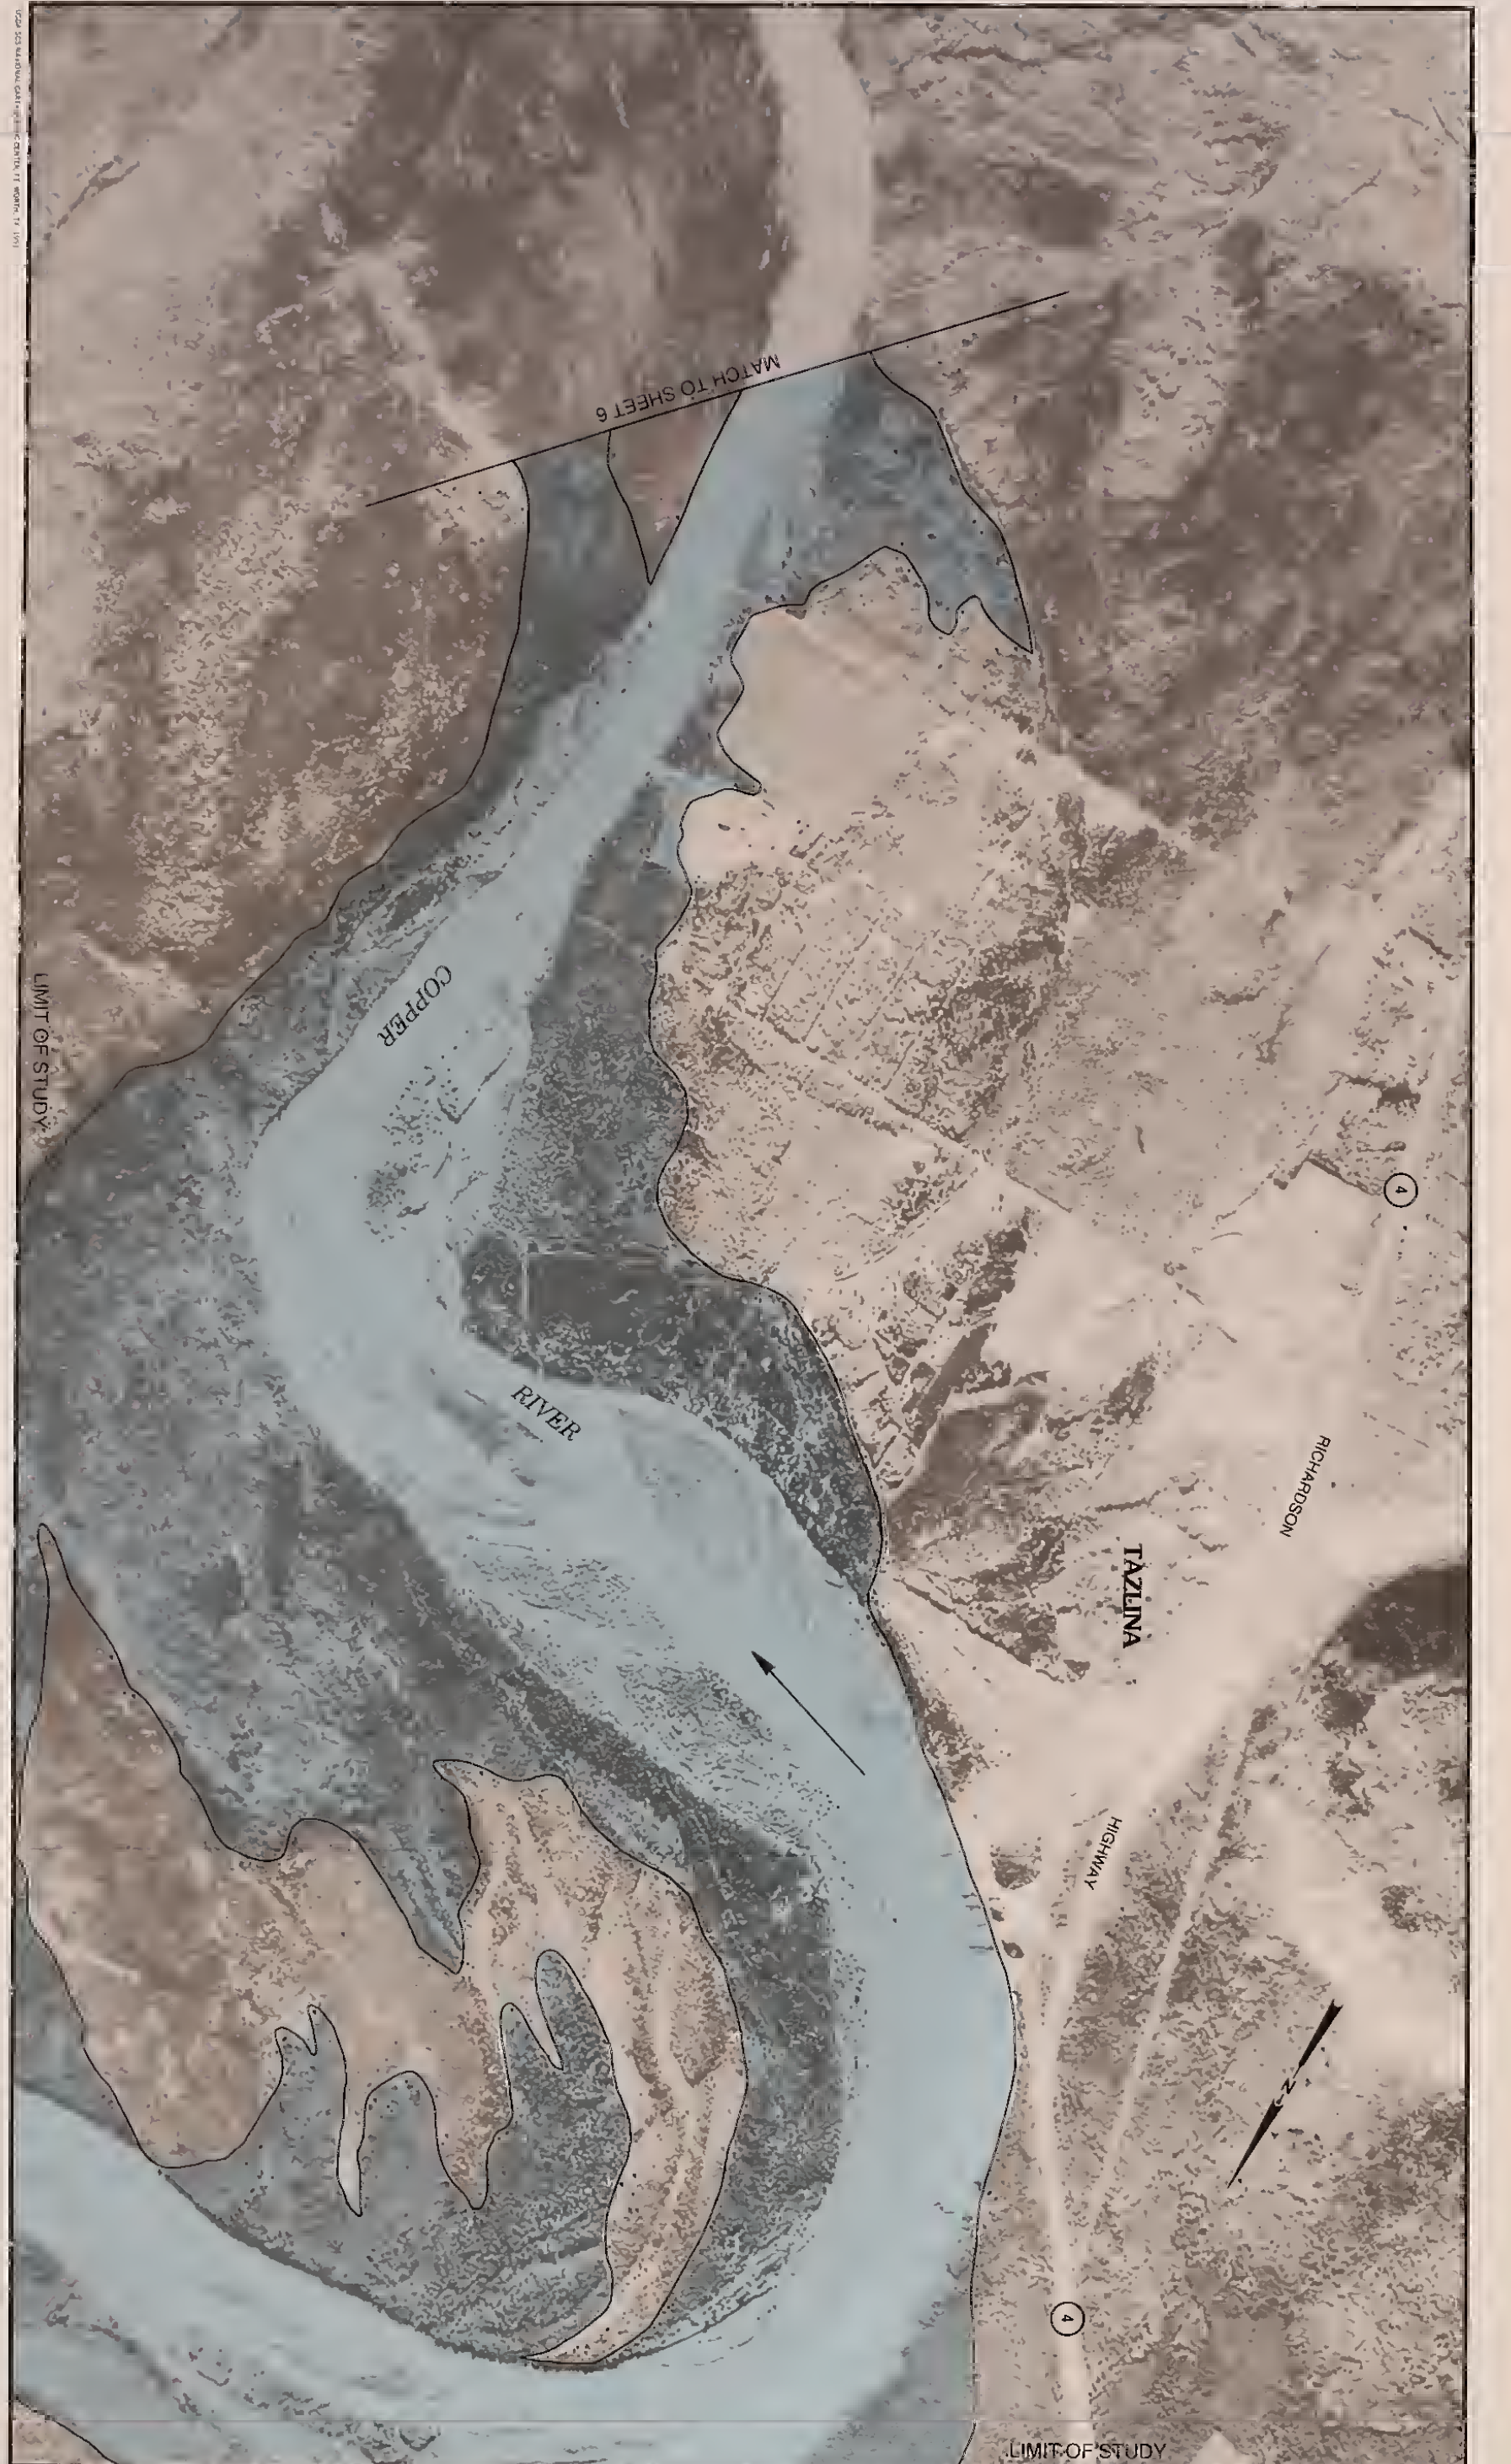
**FLOOD HAZARD AREA**  
**TAZLINA AND COPPERVILLE**

U.S. DEPARTMENT OF AGRICULTURE  
SOIL CONSERVATION SERVICE  
COPPER RIVER COMMUNITIES  
FLOOD PLAIN MANAGEMENT STUDY AREA  
ALASKA
